Florida Housing Coalition Hurricane Member Update Webinar

January 21, 2022
Sponsored by Fannie Mae

Moisture Problems in Manufactured Housing

JANET MCILVAINE

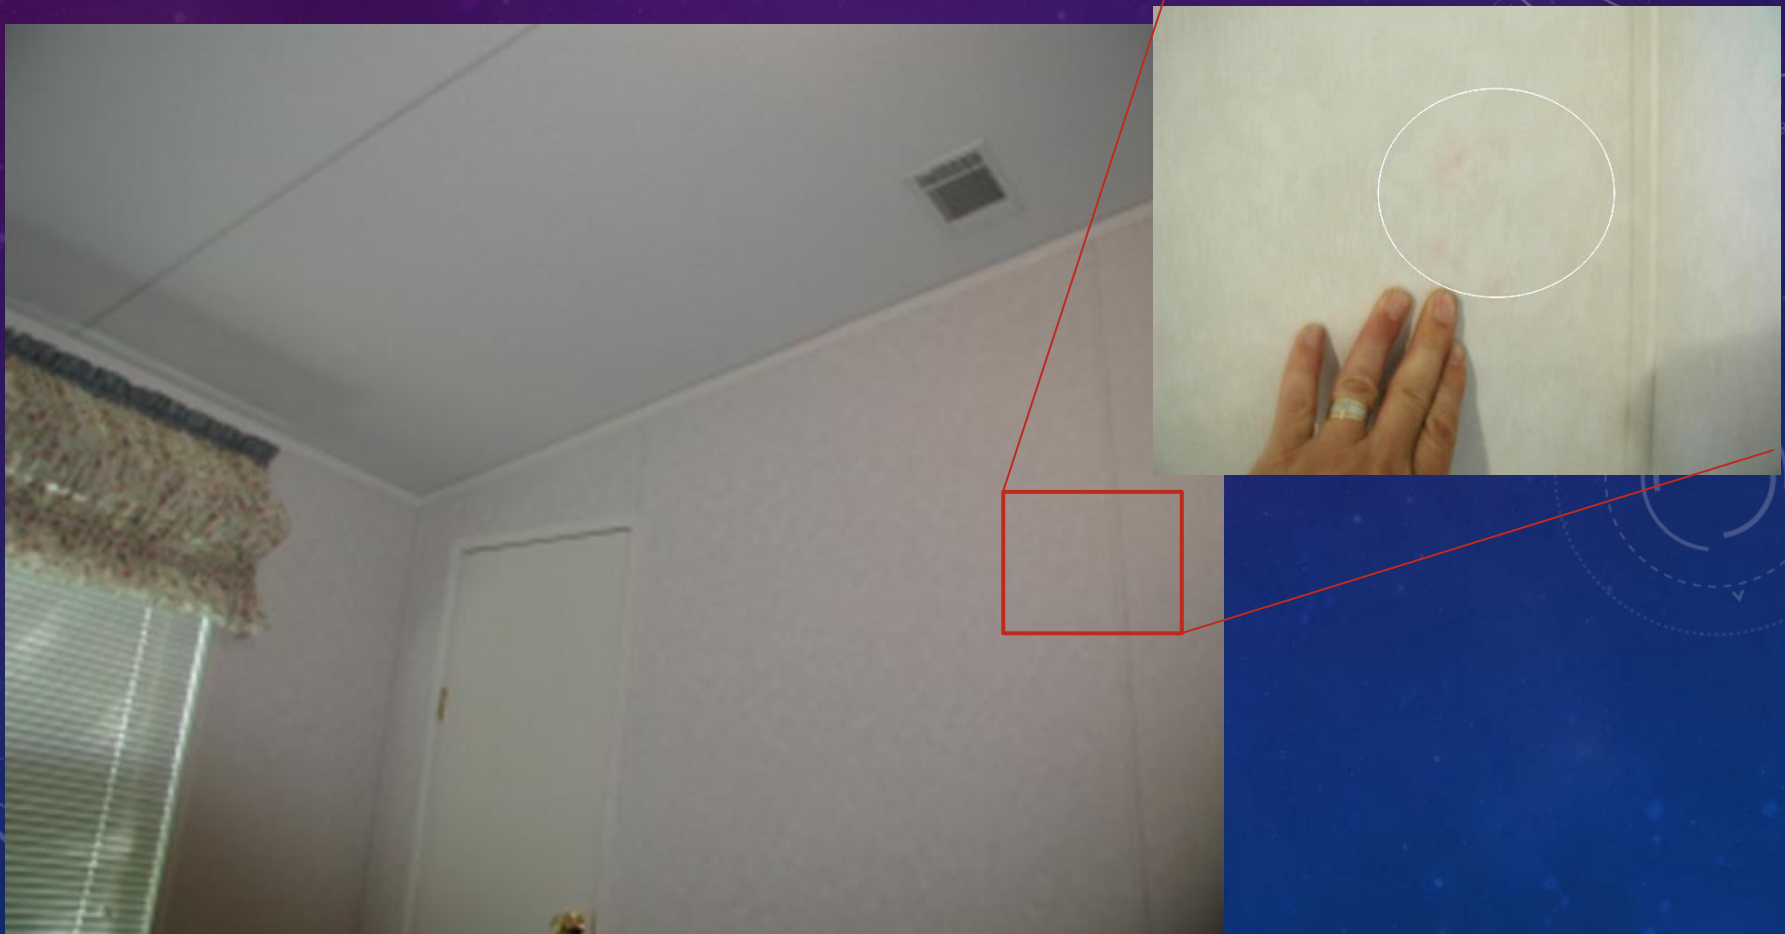
Pink mold on wall paneling
High humidity, cold walls
Mold loves 60%+ relative humidity

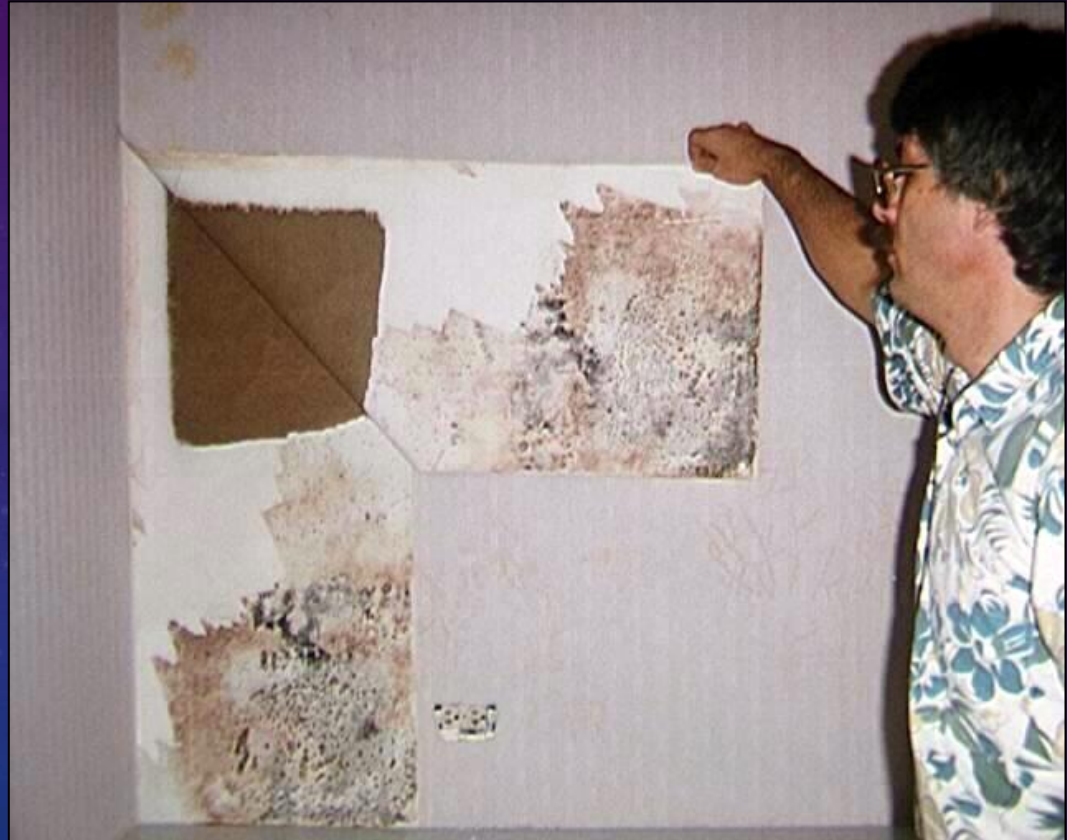
Mold growth behind vinyl wall paper

- Room depressurized
 - Duct leakage, door closure
- Outdoor air/moisture pulled into wall assembly
- Can't go through vinyl wall paper
- Viola! Very high surface humidity
- Mold loves wet paper!
- Do not disturb the mold
- Remove all molded materials

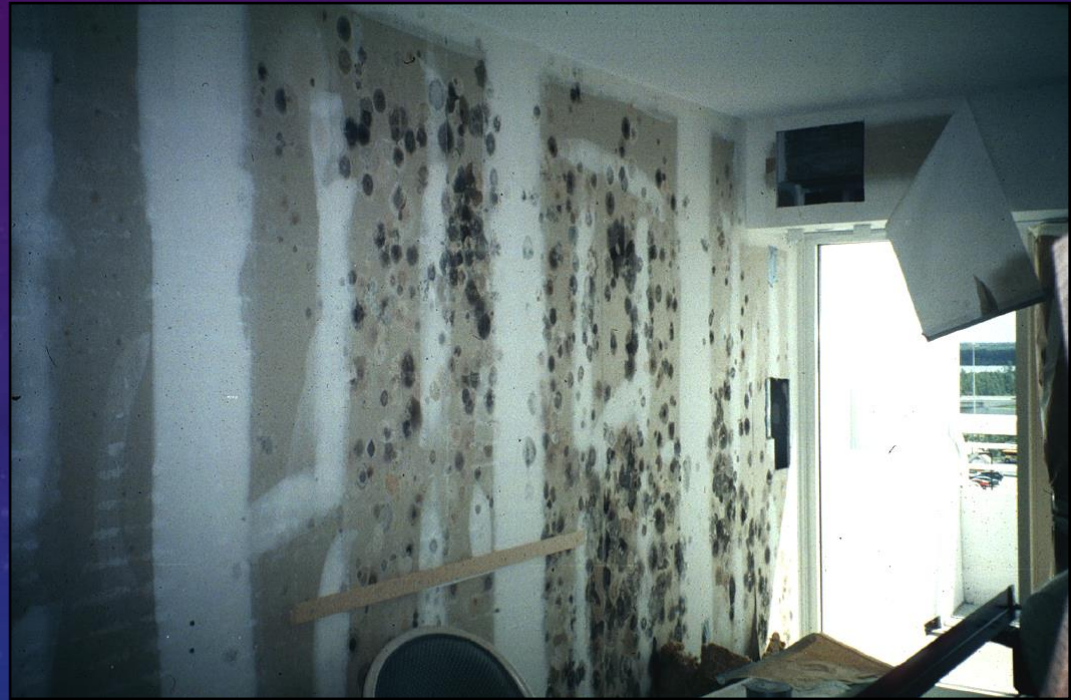
Mold growth behind vinyl wall paper

- Room depressurized
- Outdoor air/moisture pulled into wall assembly
- Can't go through vinyl wall paper
- Viola! Very high surface humidity
- Mold loves wet paper!
- Do not disturb the mold
- Remove all molded materials

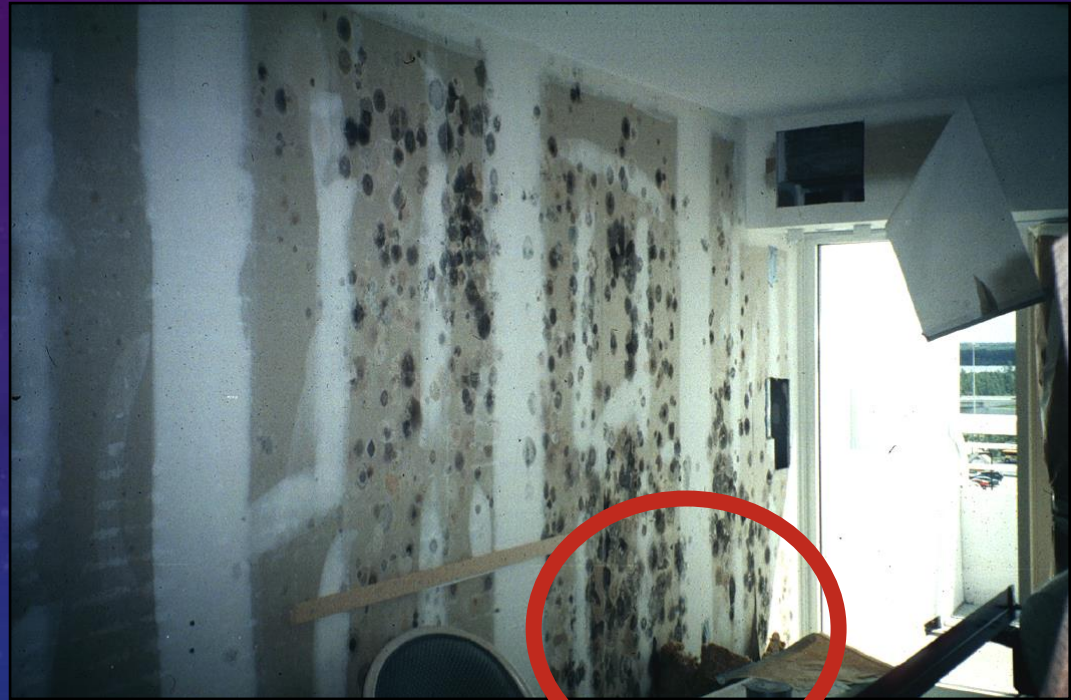
Biological growth behind vinyl wall paper

- Room depressurized
- Outdoor air/moisture pulled into wall assembly
- Can't go through vinyl wall paper
- Viola! Very high surface humidity
- Mold loves wet paper!
- Do not disturb the mold
- Remove all molded materials

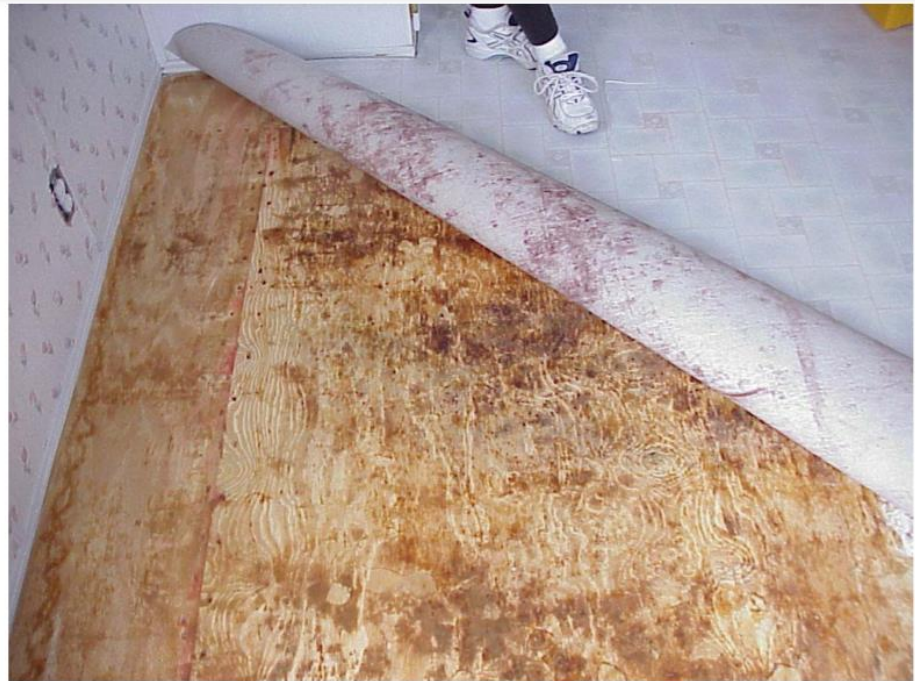
Figure 8 The floor covering has been partial removed. The plywood flooring was wet to the touch and staining exists on much of the under side of the vinyl. The floor decking was removed to inspect the underside – it appeared dry.

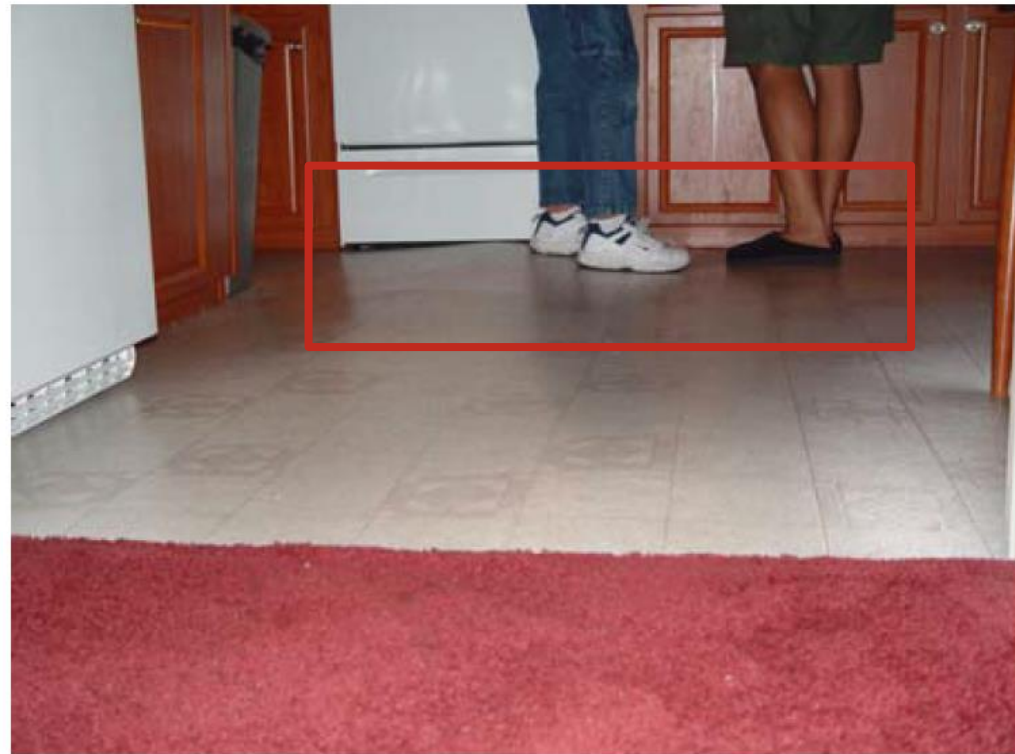
- High RH in crawl space
- Depressurized house
- Moisture collects in sub floor, can't go through the vinyl

Figure 1. Warped floor

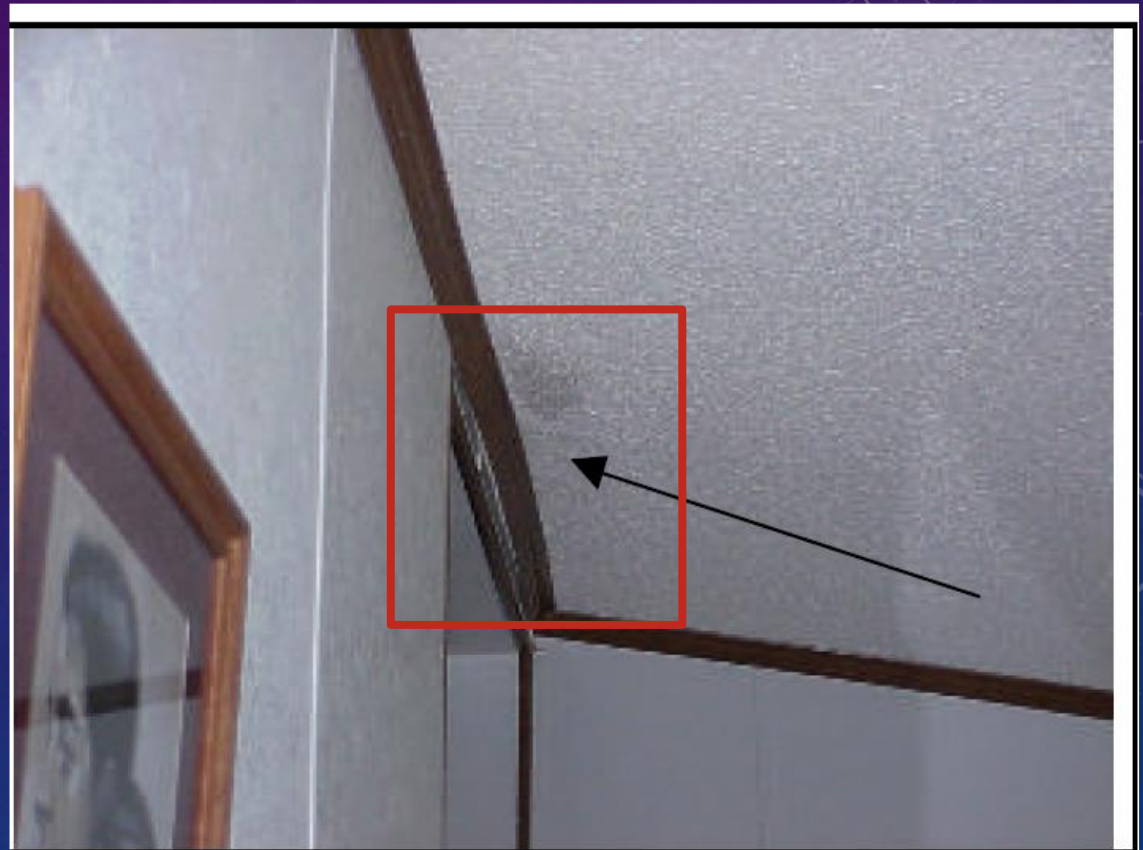
Moisture damage at ceiling edge of marriage wall

- Missing gasket at outer edge of marriage wall
- House depressurized by duct leakage
- Pulling air in through unsealed edges of marriage wall.

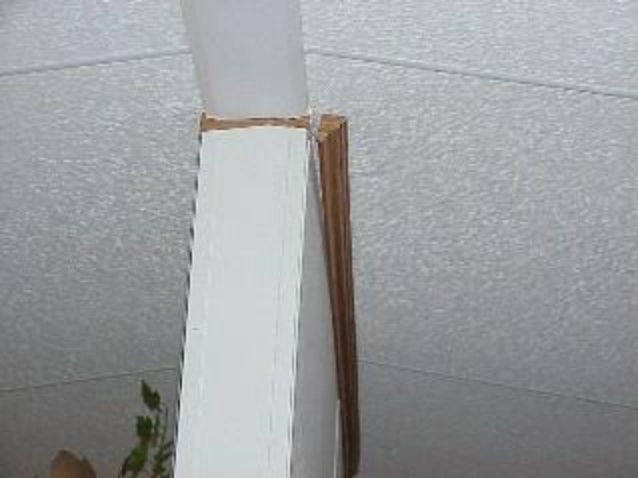
Warped trim and staining in living room

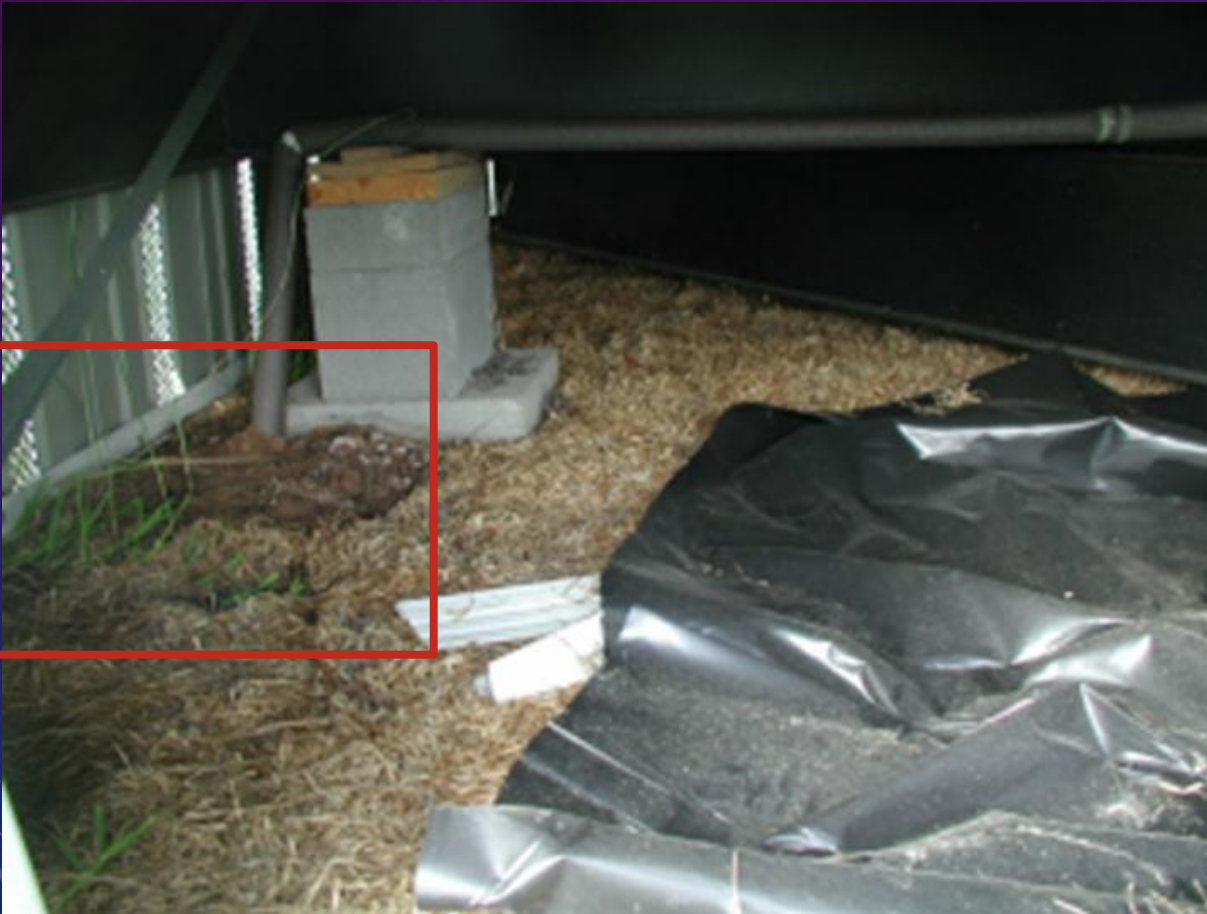
Vegetation indicates ground water
High RH in crawls space increases risk of condensation, rust
Enticement for foraging critters

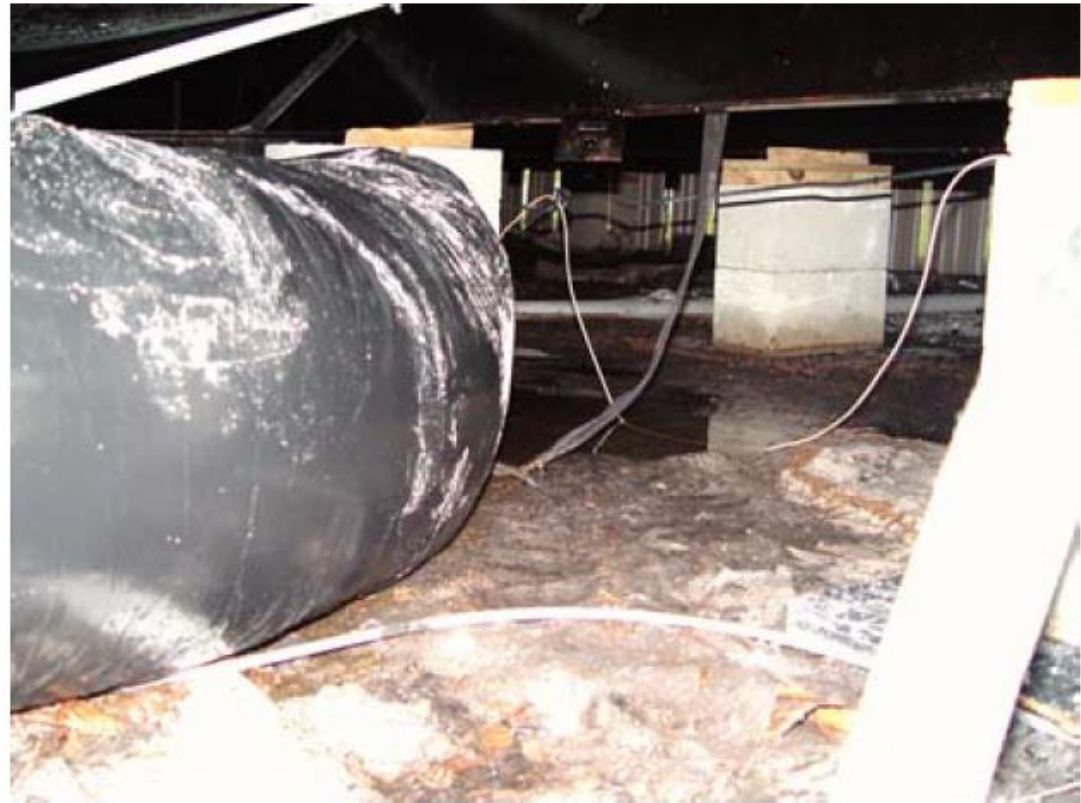
Figure 3. Standing water under house. Also note the duct work resting on the ground, absorbing the standing water.

- Increase risk of condensation, rot, rust.
- Standing water
- Direct site drainage away from house with gutters, gullies, ditches
- Fill low spots

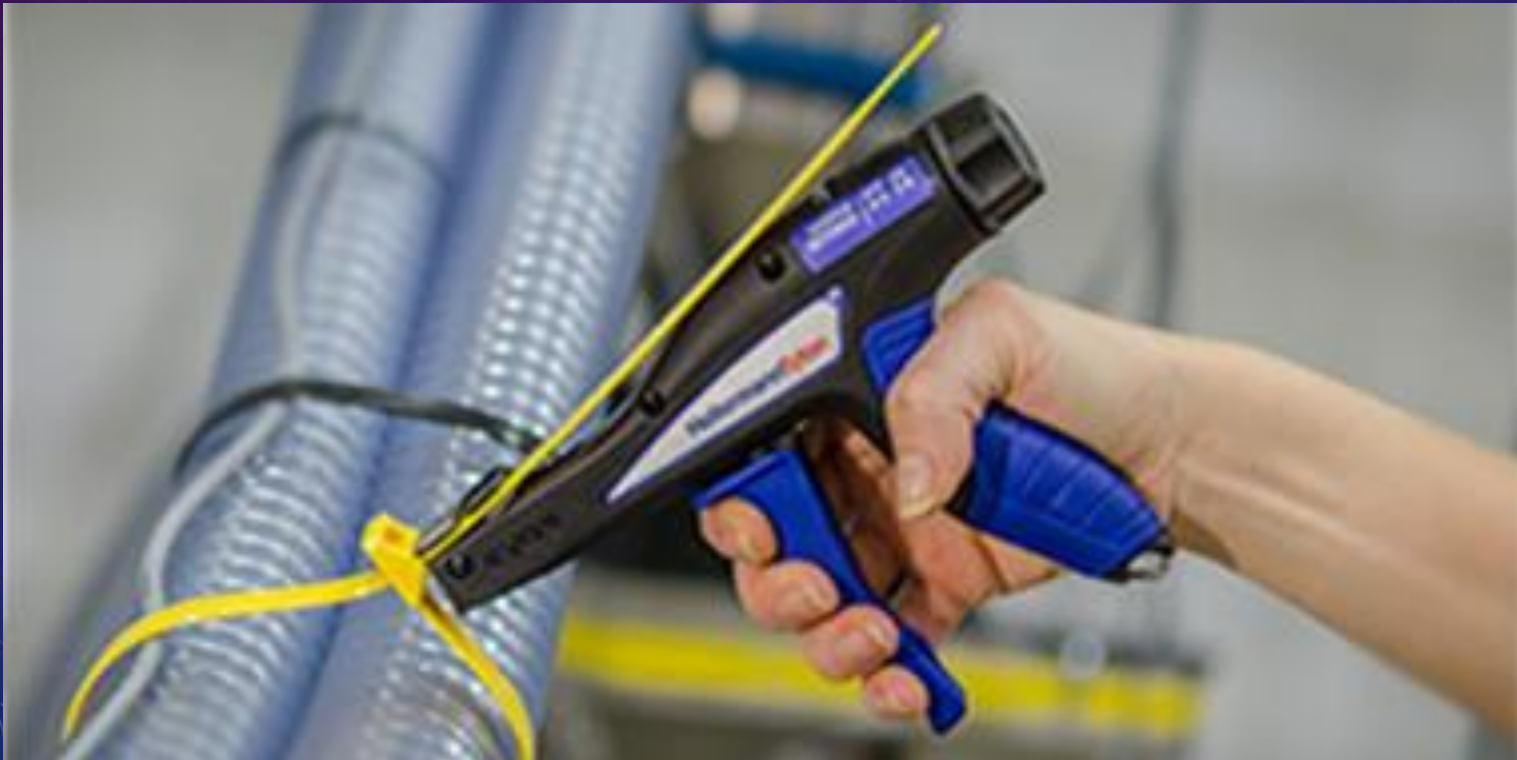
Not tightened with tensioning tool
(from a different house)

- You shouldn't be able to get your fingers between duct and zip tie

- Replace disconnected duct material – contamination risk
- Duct connections need to be STRONG
 - Clean collar
 - Zip tie inner lining to metal collar with tensioning tool
 - Position insulation layer to completely cover the metal collar
 - Zip tie for outer lining to collar with tensioning tool
 - Best practice: connect outer lining to rigid/metal duct with mastic and fiberglass substrate

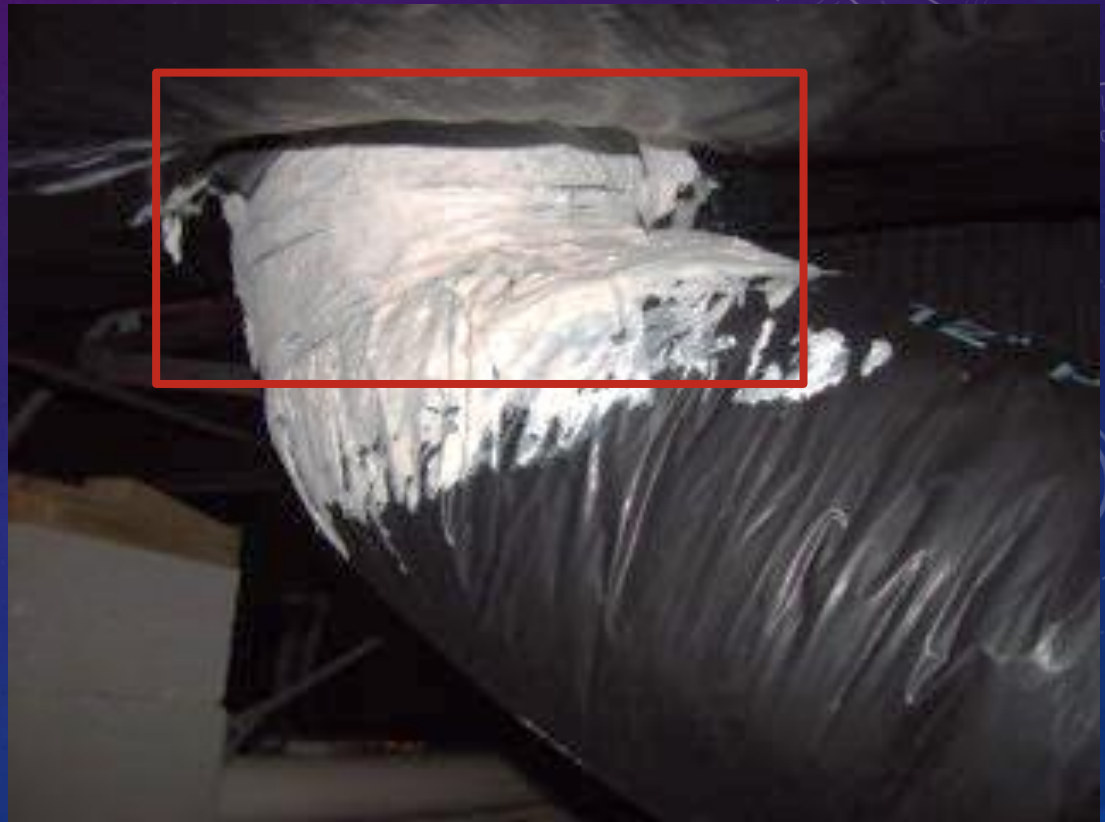
Well intended mastic sealing at flex to collar connection

- Well sealed
- BUT
- Compressed insulation led to condensation anyway
- Allow insulation and outer liner to be fully expanded around metal collar

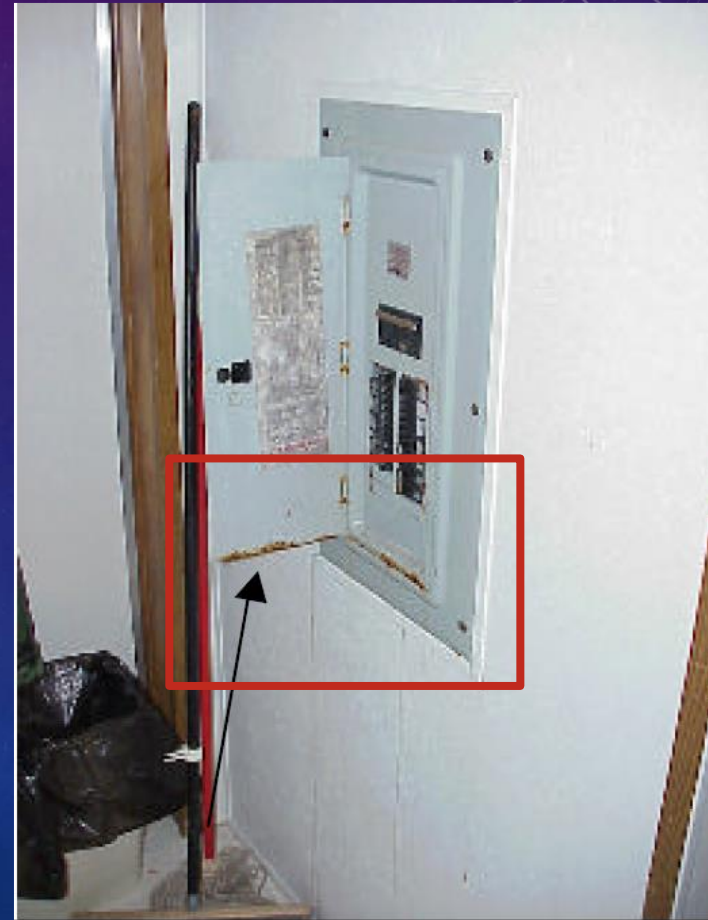
Moisture being pulled through wall cavity
Cool metal = condensation surface

- “The electrical panel box showed significant evidence of moisture; there was rust on many parts and a water stain was seen below the panel running to the floor.”

Rust on electrical service panel

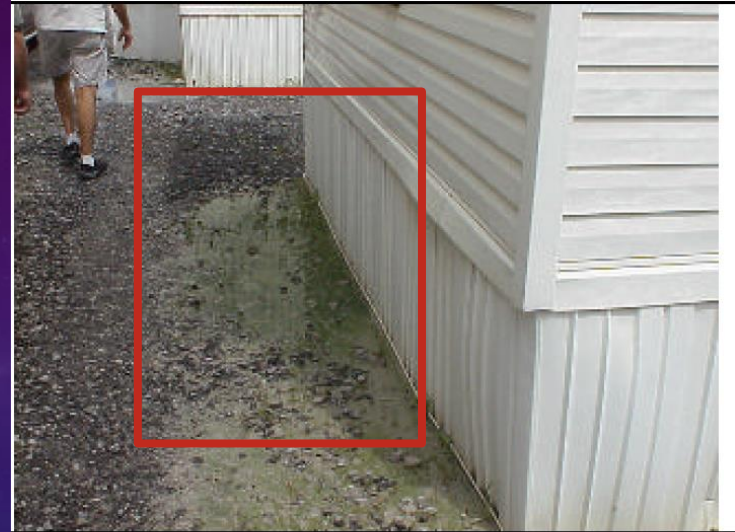
Standing water at skirting

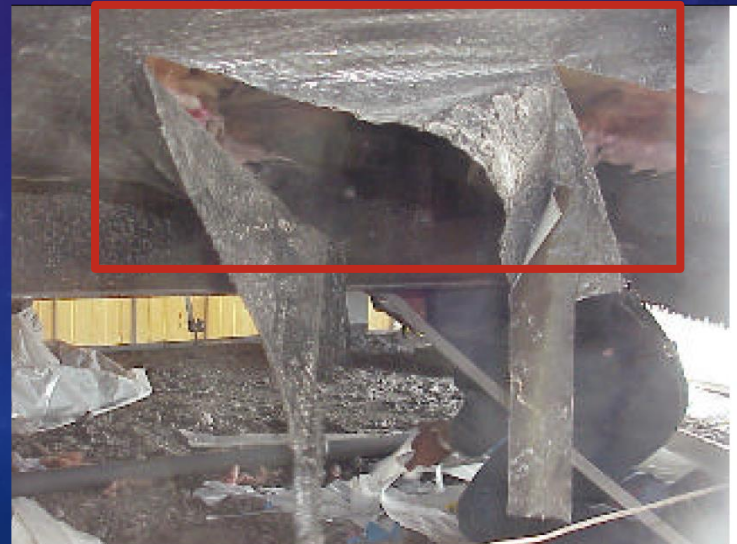
One of many penetrations in belly board

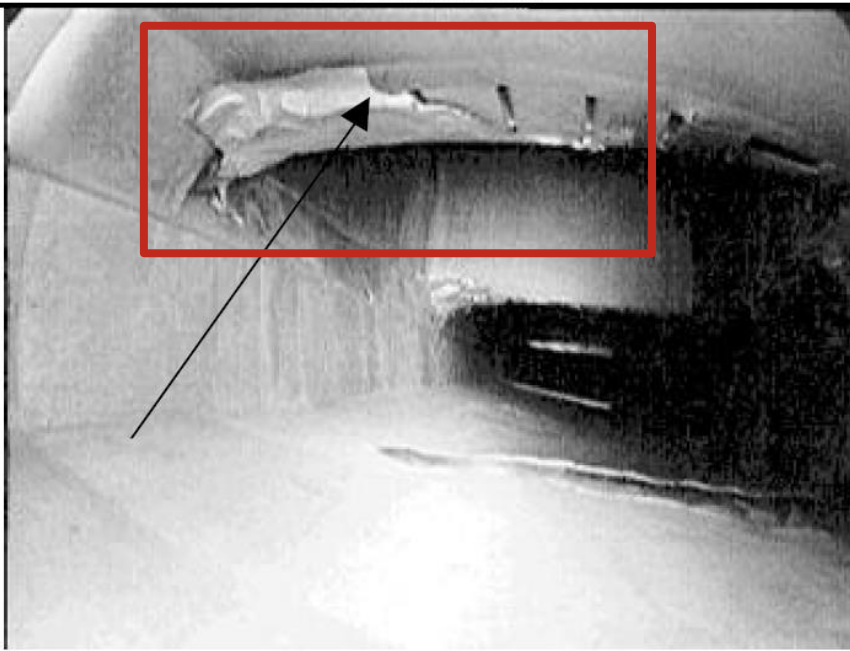
View inside the duct- note missing tape

Seal connection of riser to trunk and to subfloor with mastic and fiberglass tape

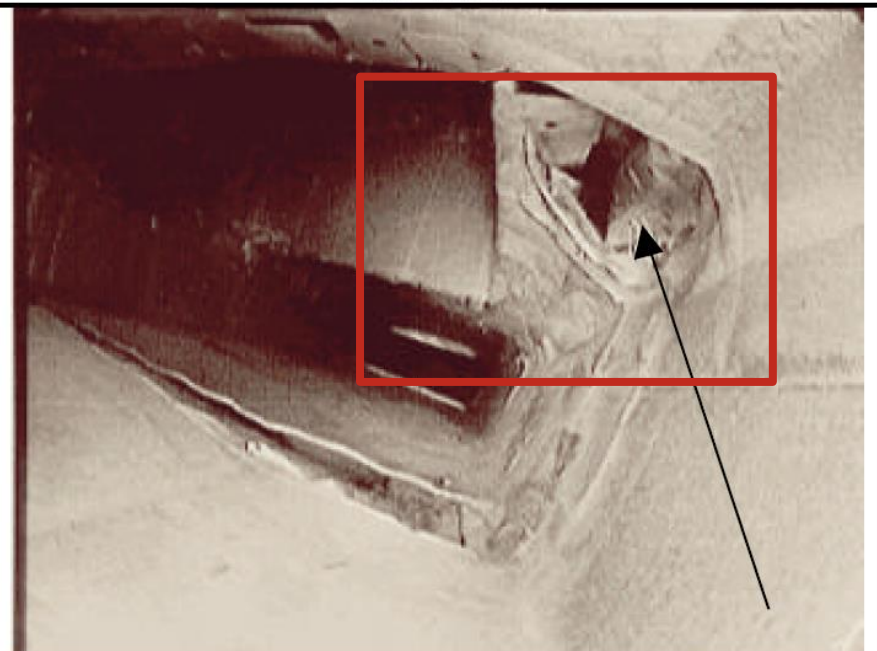
View at plenum – note large hole

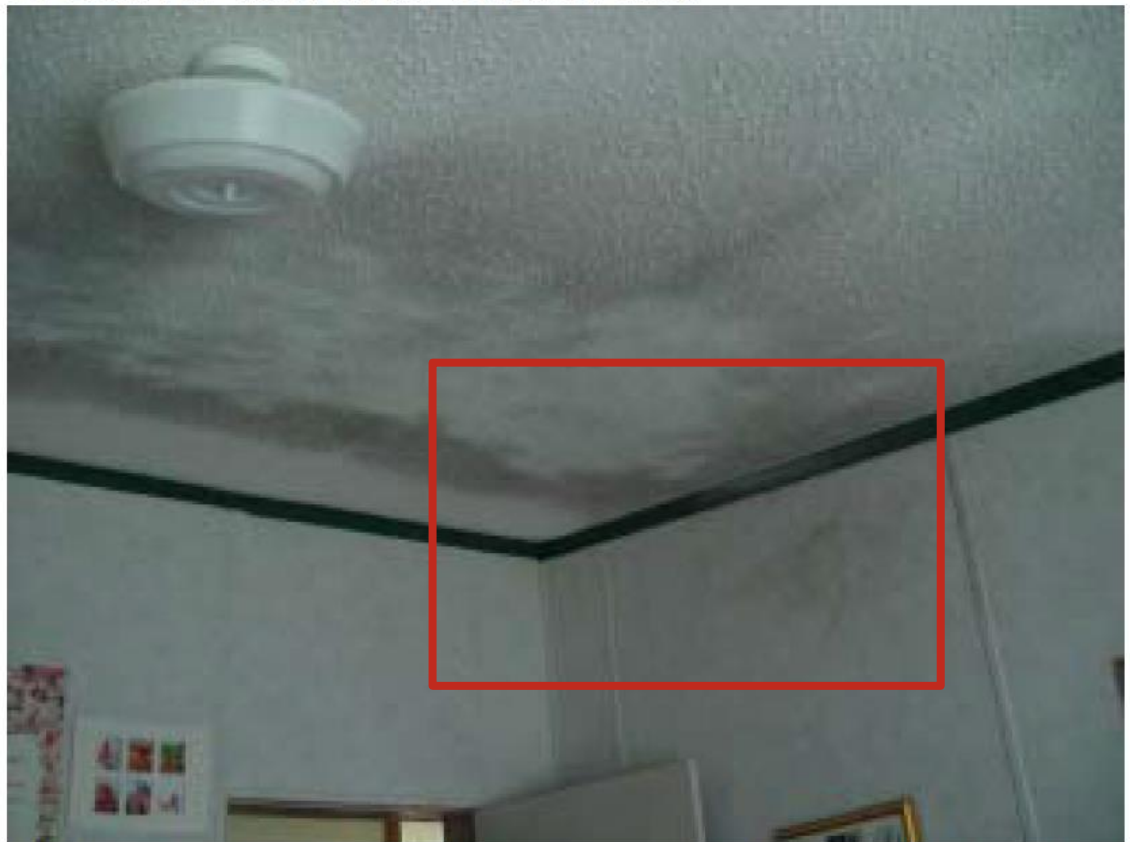
- Biological growth, staining problems, and condensation on interior surfaces

SW corner bedroom-homeowner indicated that water runs down wall near corner

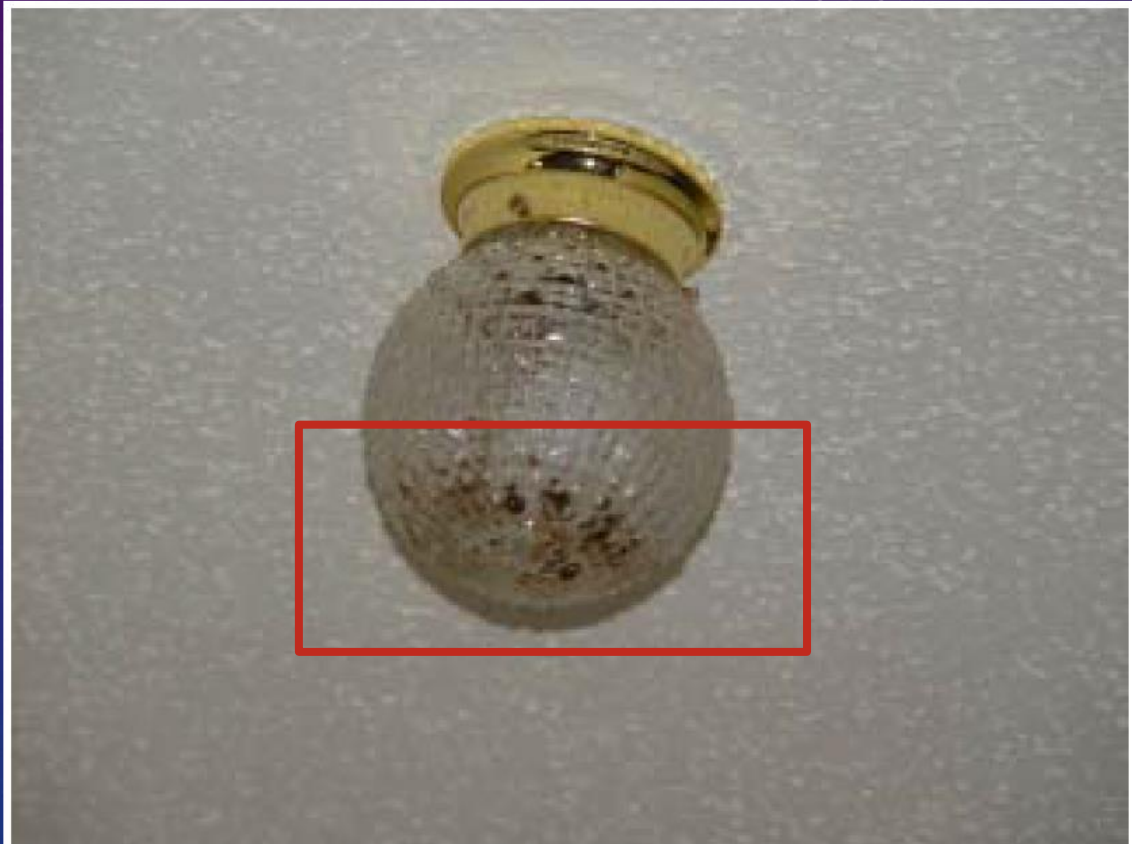
- Water inside the hall light fixture and running out of electrical outlets located on the kitchen marriage line

Hallway ceiling fixture with evidence of moisture within the globe

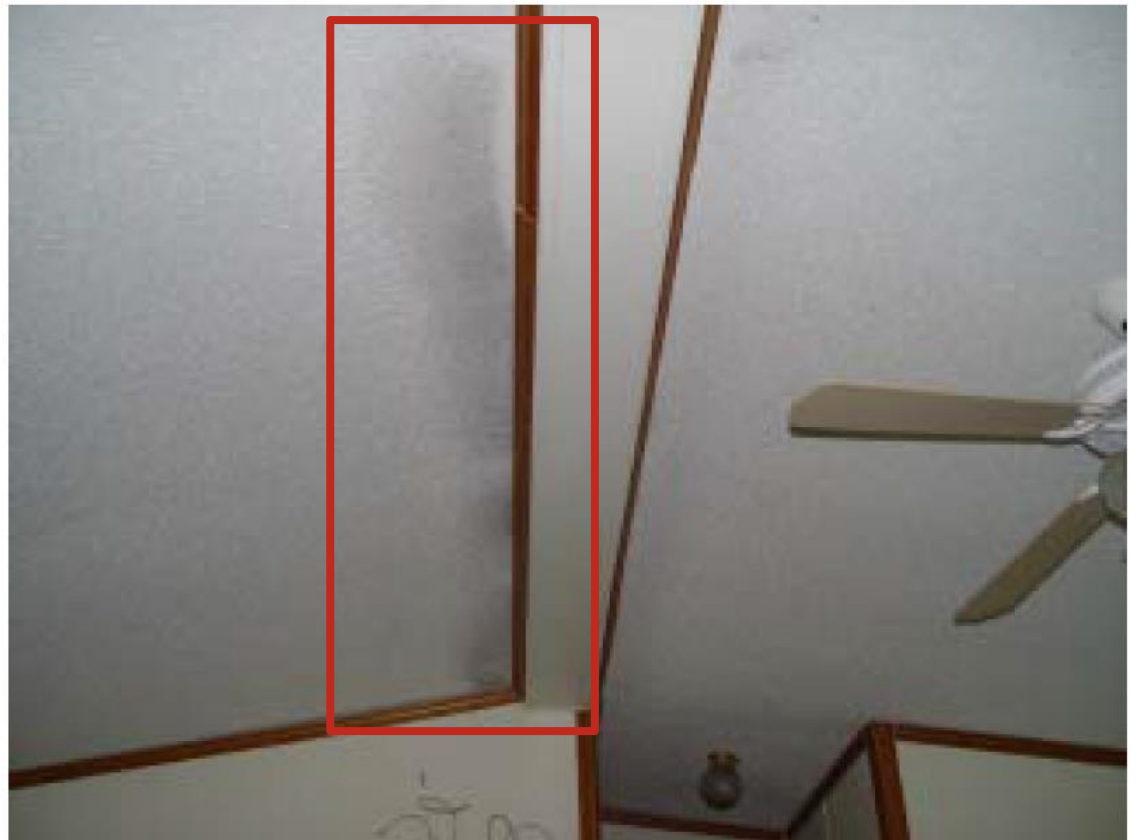
- Soft and bowing wallboard on the marriage line
- Staining at marriage line

“Staining” of ceiling near marriage line

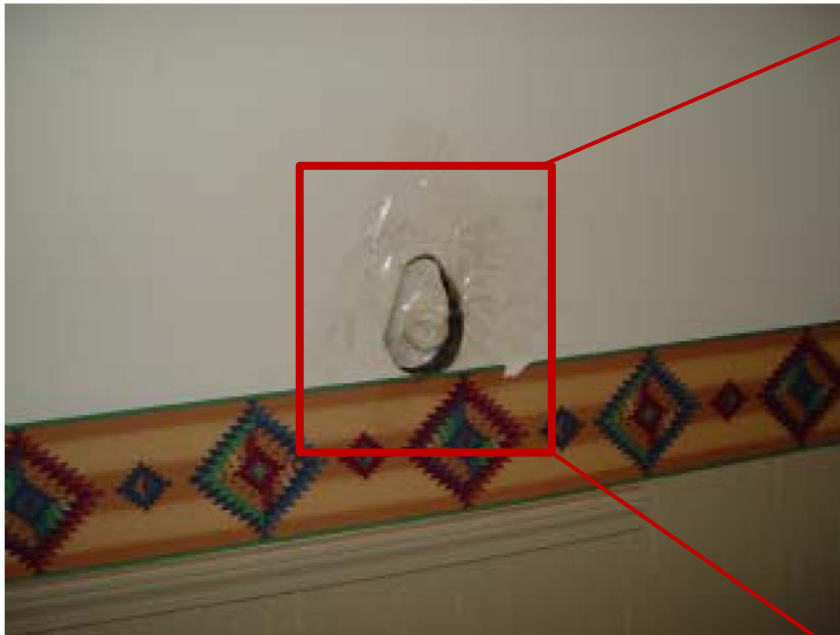
Master bedroom marriage line wall doorknob damage as a result of humidified materials

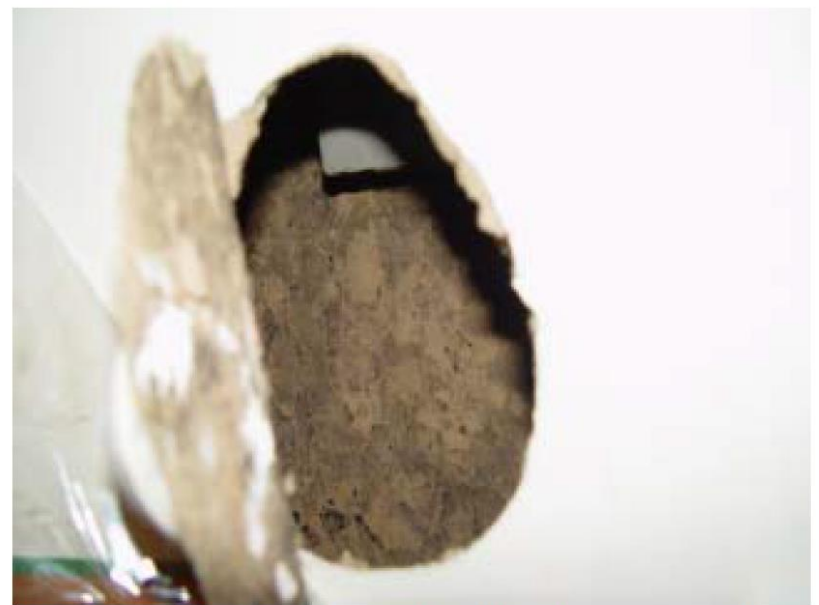
- Soft wall board, biological growth in wall cavity

Evidence of biological growth within the marriage line wall assembly common to master suite and kitchen.

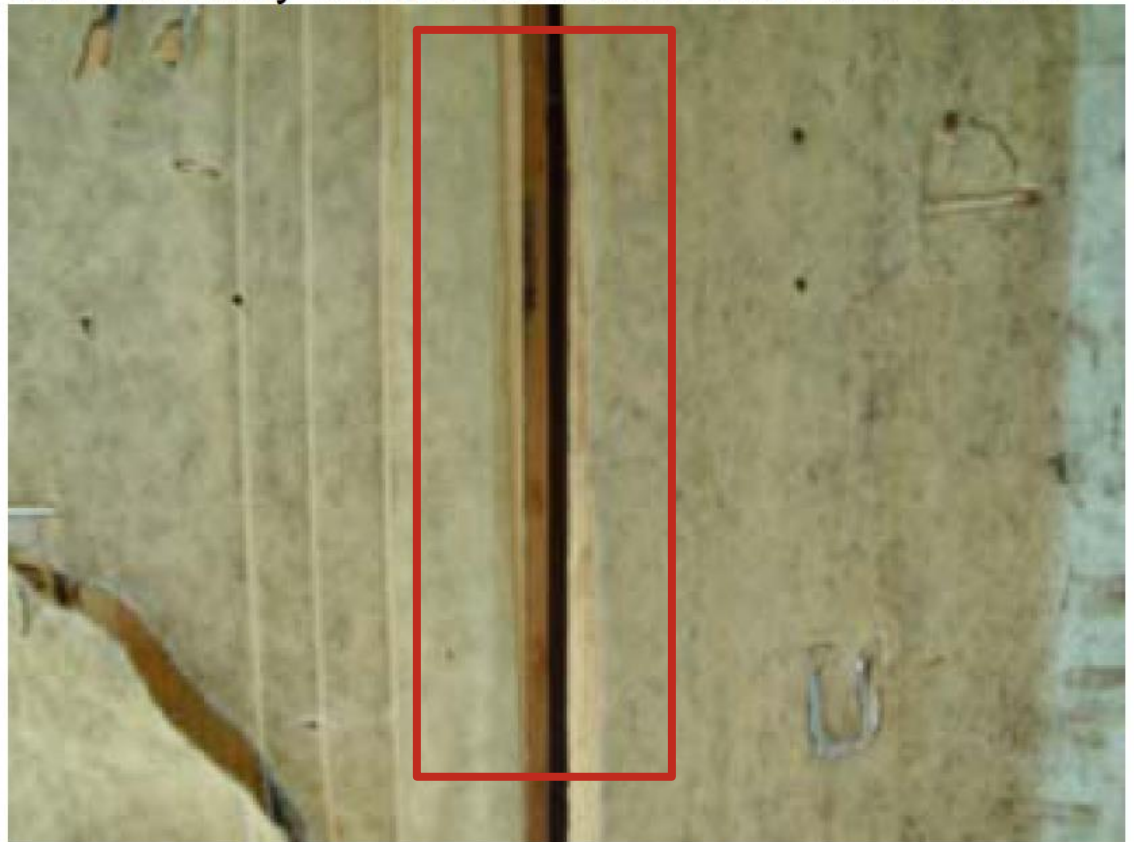
- The situation
 - No gasket at marriage line
 - Marriage wall fully connected to crawl space
 - Crawl space conditions fair/poor

East side marriage line – does not appear that any seal was installed or applied

- Inspect marriage line in crawl space and at ceiling
- Where gasket is missing, fill spaces with air barrier material (rigid foam, sill seal, backer rod)
- Seal edges and joints of new air barrier material
 - Small cracks: long life caulk (e.g. silicone)
 - Larger cracks: mastic and fiberglass “tape” and long life sealant
- Changes in occupancy can bring on new moisture problems from additional cooking, bathing, and laundry
 - Install exhaust fans, duct to outside *not crawl space*

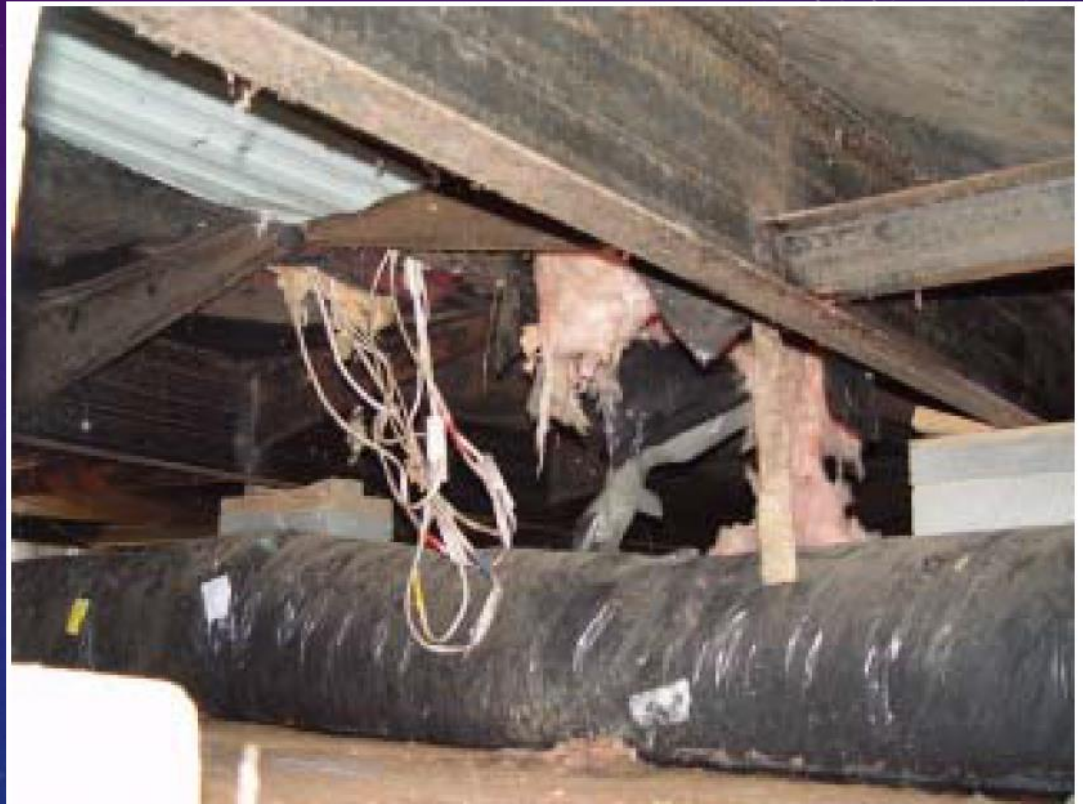
- Marriage wall fully connected to crawl space
- Missing belly board
- Missing insulation
- Duct sealing (tape) failure

Compromised belly board at marriage line

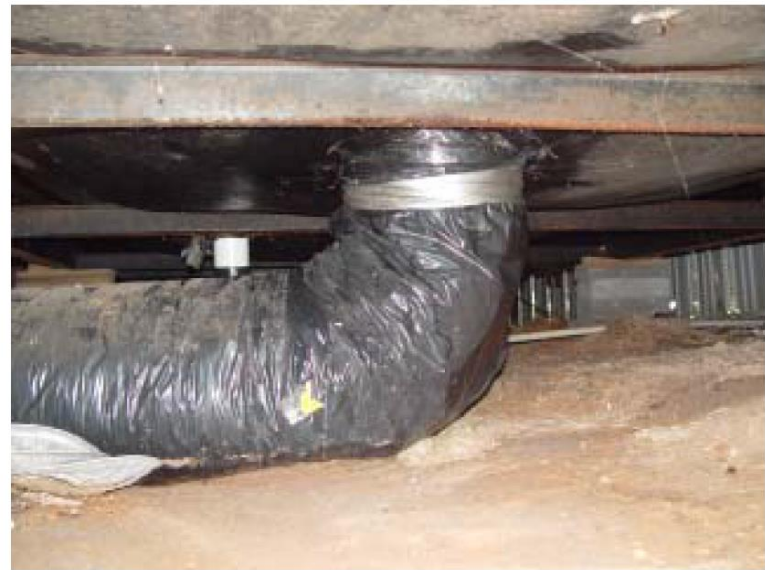
- No ground cover, duct in contact with ground
- Could be worse! No standing water, tide lines, or growth

Crossover duct under master suite
