Florida Housing Coalition Hurricane Member Update Webinar

January 21, 2022
Sponsored by Fannie Mae

Moisture Problems in Manufactured Housing

JANET MCILVAINE

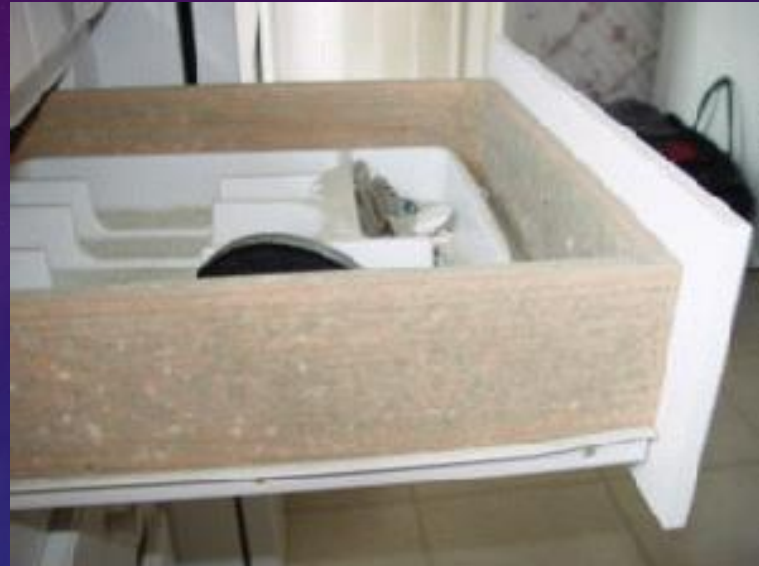
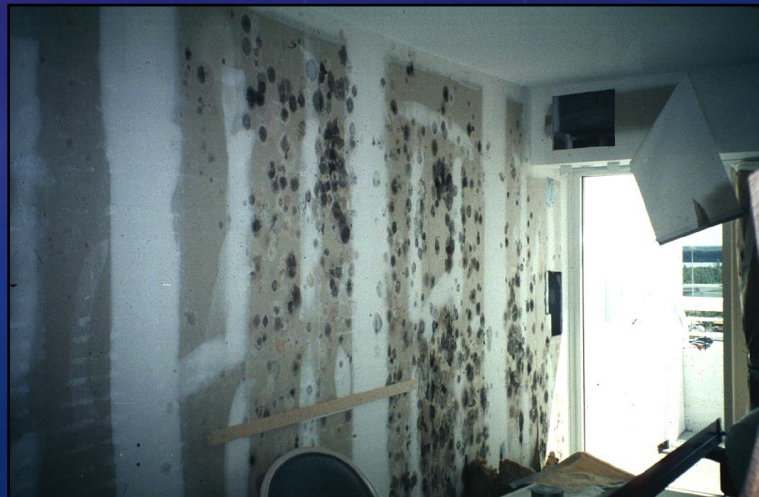
Observe and document patterns and concentration

- Evenly distributed mold growth, indicates high humidity throughout space
- Concentration of mold indicates a point source and direction of moisture flow

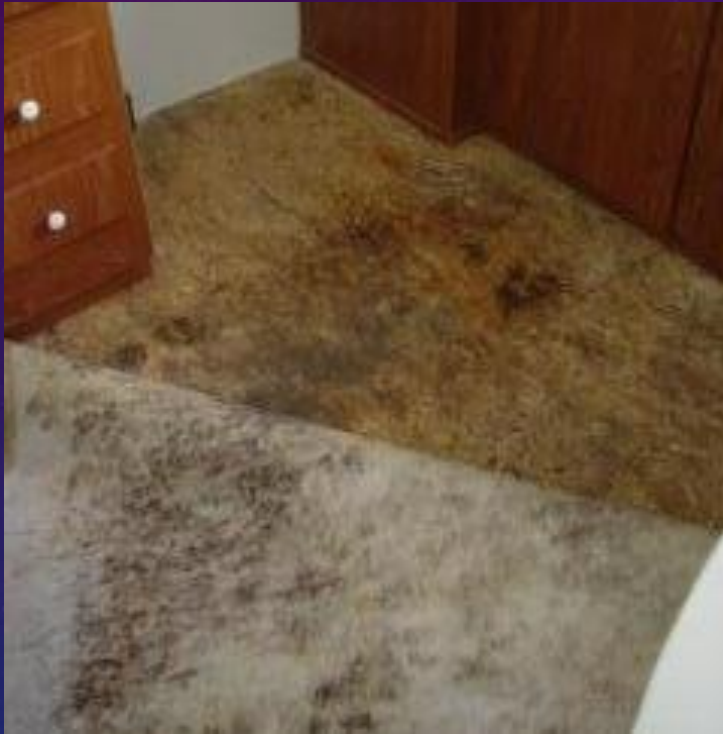
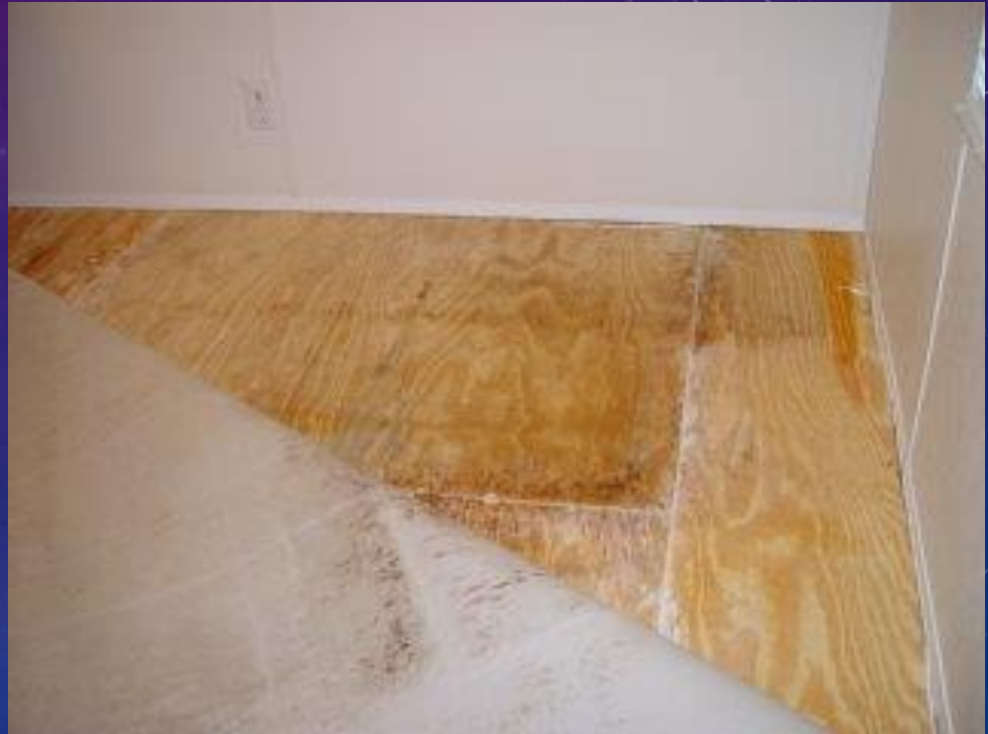
Biological growth under vinyl flooring

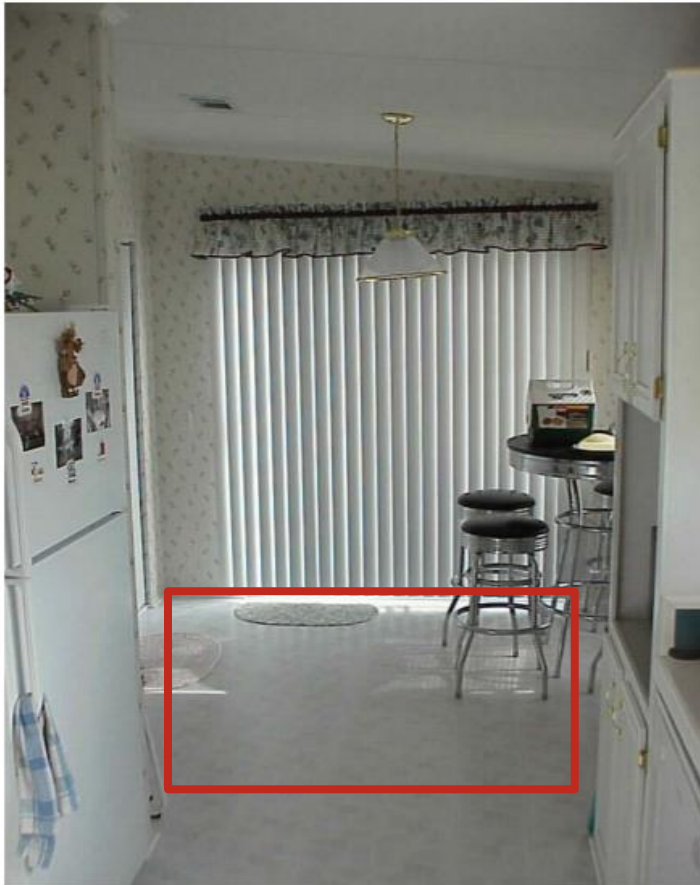
Overhead supply register + holes in belly board
Crawl space air in contact with surface at dew point
High surface RH = mold growth

Figure 7 Breakfast nook with a vinyl floor covering and overhead supply register. Visible discoloration of the floor (pink spots) existed primarily in the area between the table and the cabinets on the right side of the picture. The supply register was oriented as to blow air to the outside wall.

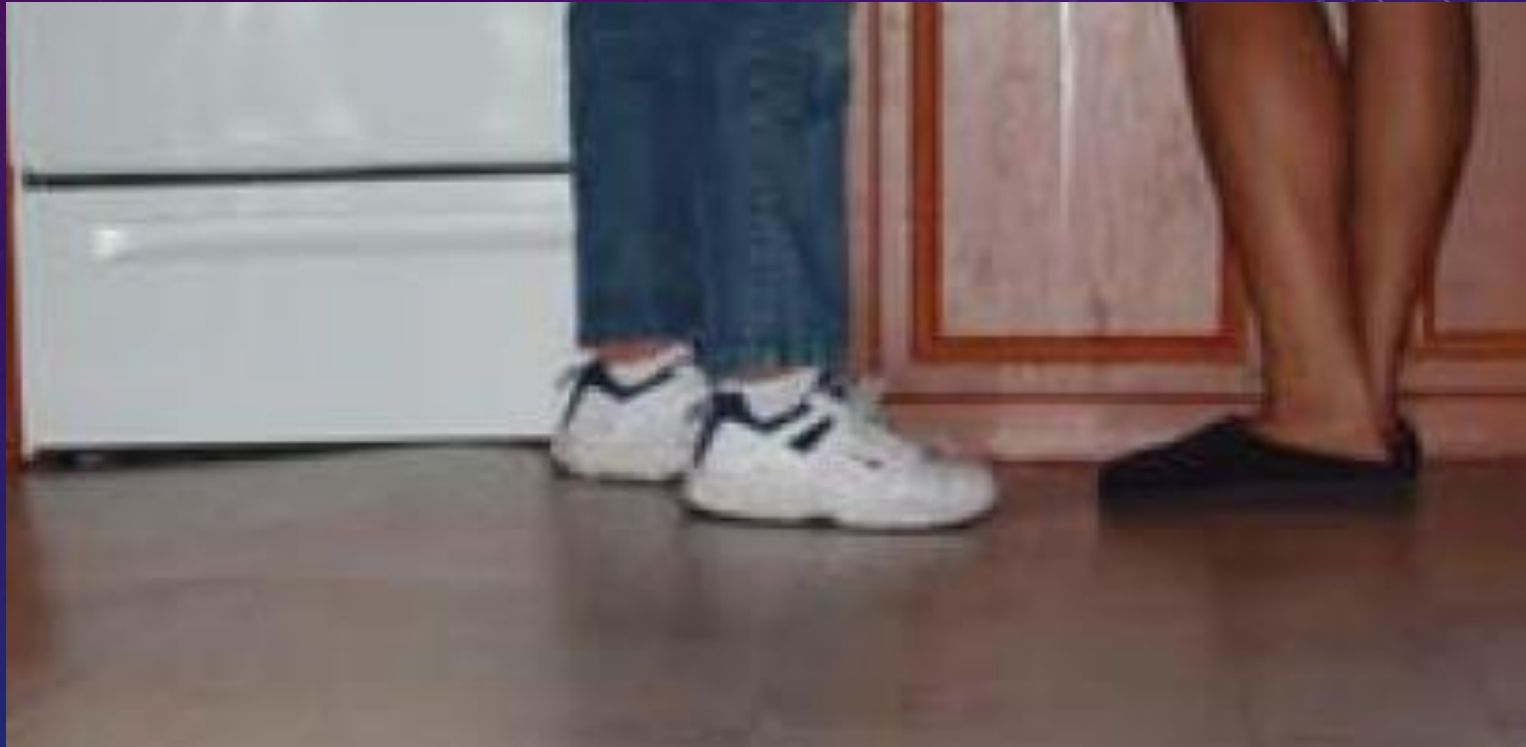
Warped floors

- High RH in crawl space
- Depressurized house
- Moisture collects in sub floor, can't go through the vinyl

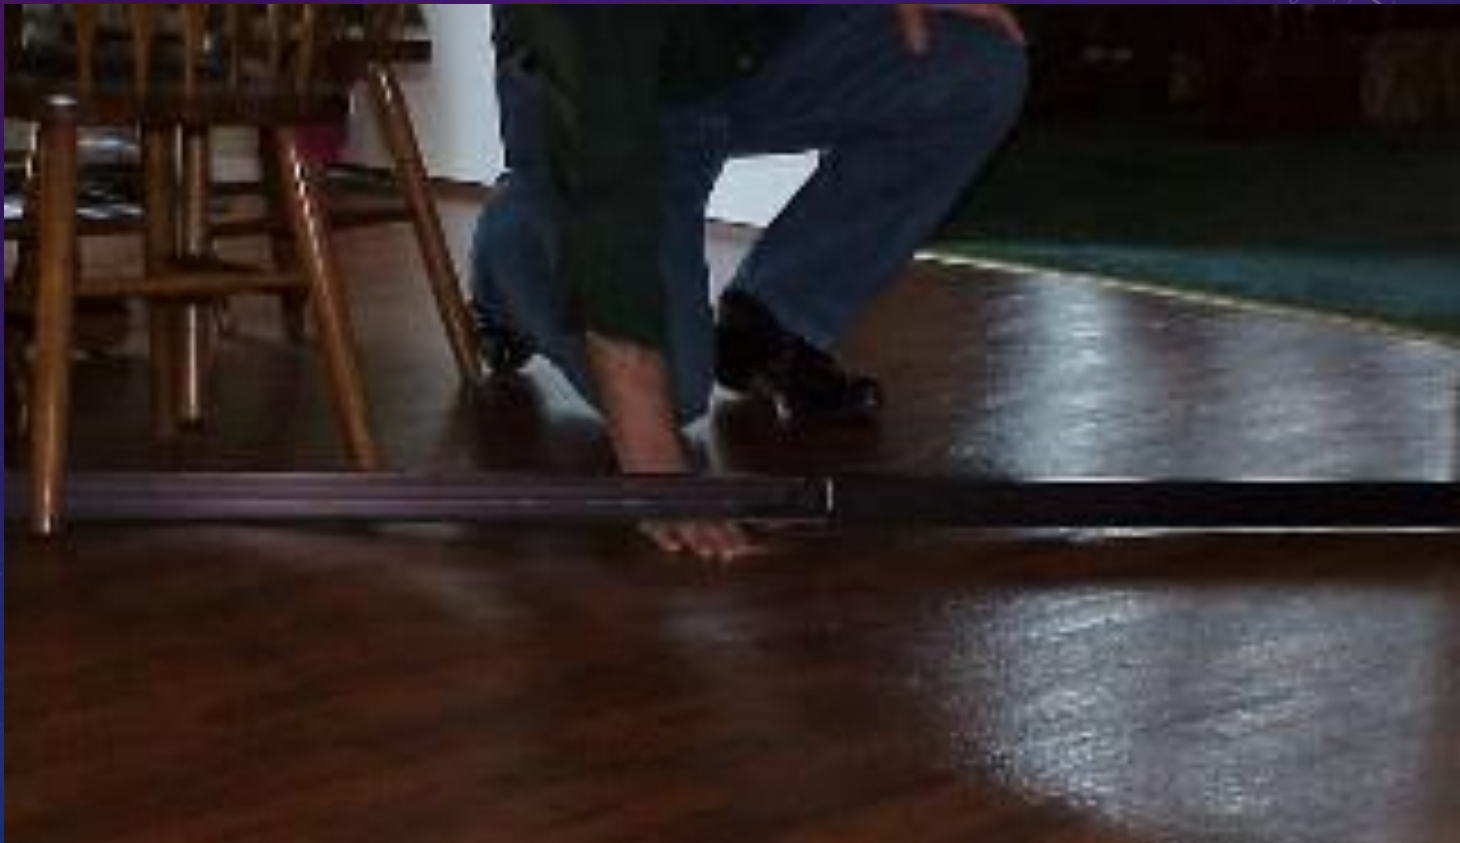
Warped floors

Moisture from crawl space absorbed by sub floor

Vinyl flooring stops moisture movement

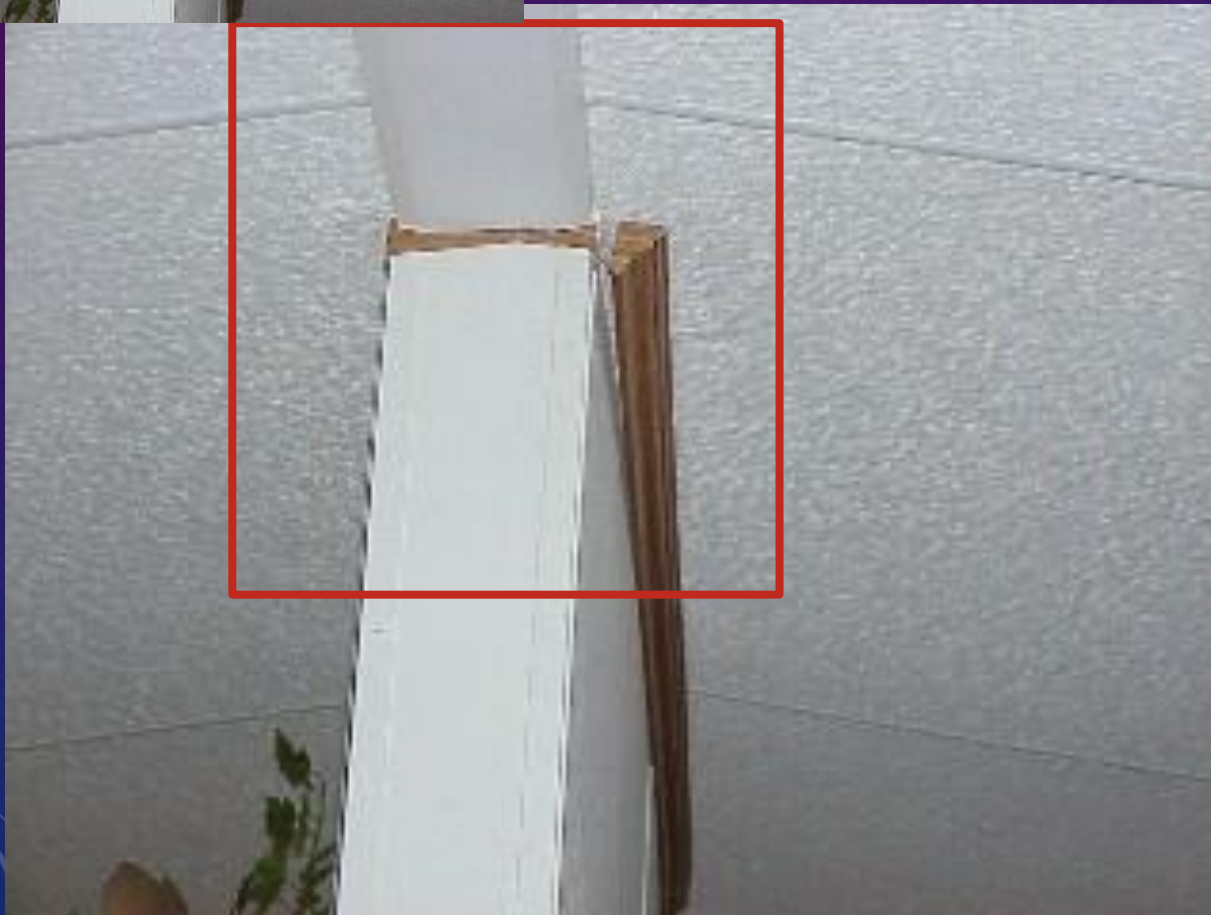
ures

+ missing gasket =

marriage wall, wall board bowed

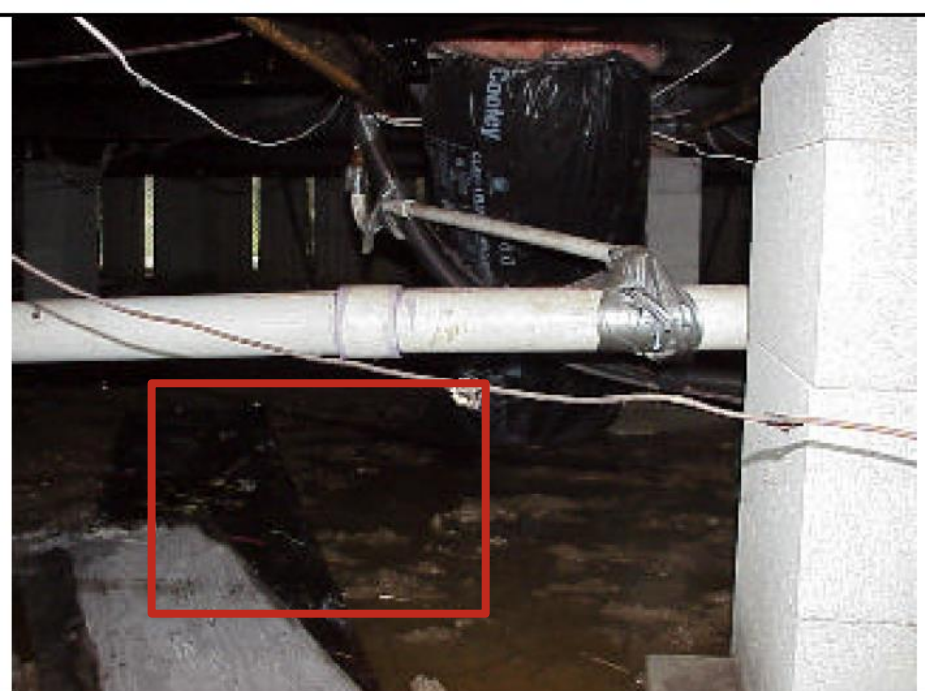
High Tide Lines

Standing and flowing water increases crawl space RH

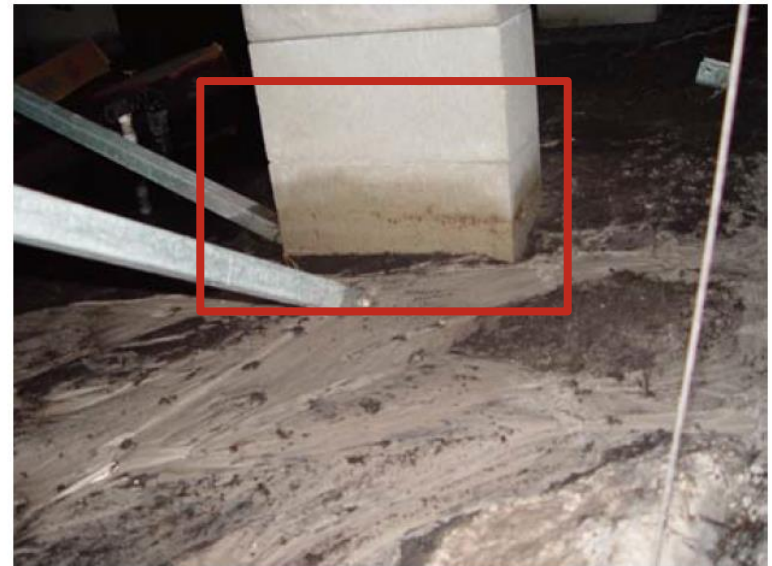
The wet crawlspace and crossover duct

Figure 4. Flow lines under house, indicating running water under the house. Also note the “tide line” again.

- Increase risk of condensation, rot, rust.
- Standing water
- Direct site drainage away from house with gutters, gullies, ditches
- Fill low spots

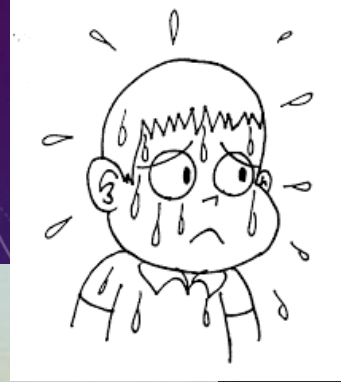
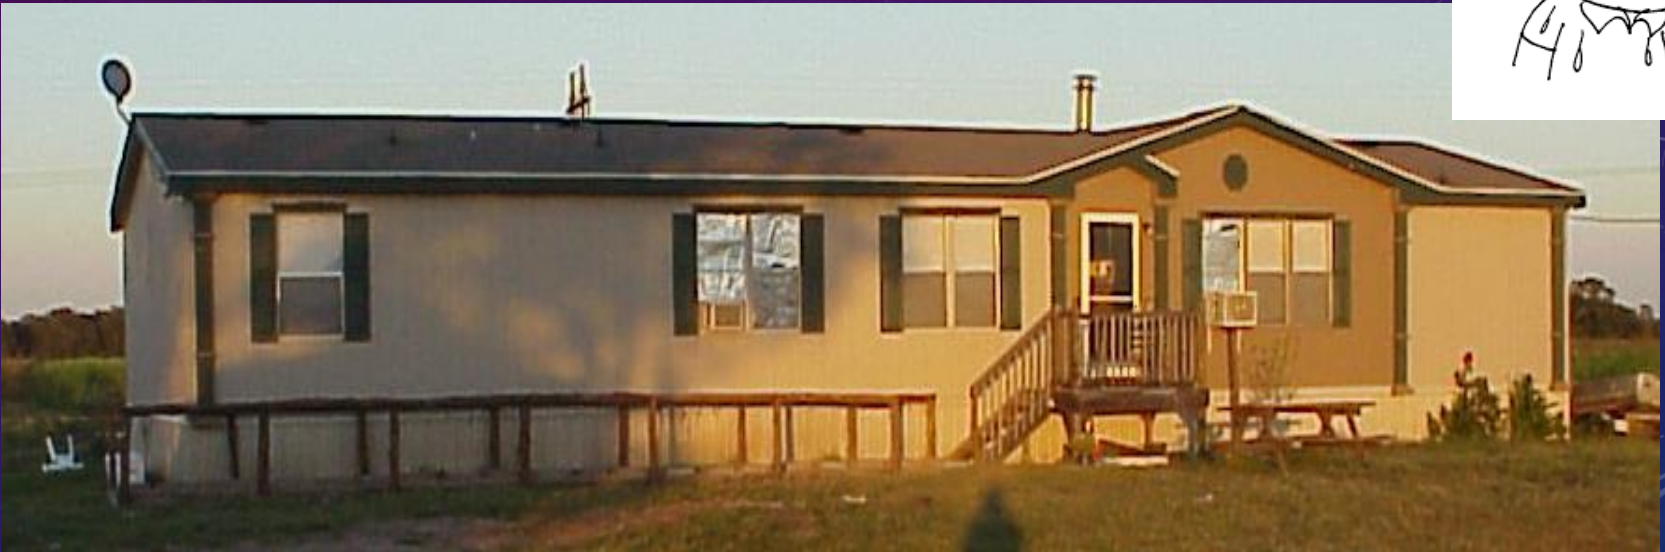
- 1998 model home
- Uncomfortable - rain forest conditions (hot & humid)
- Walls starting to buckle
- \$500+ peak utility bills

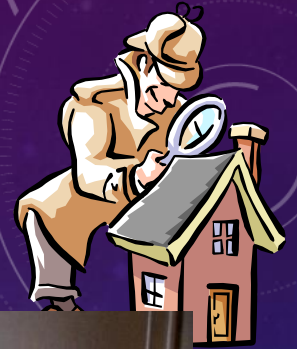
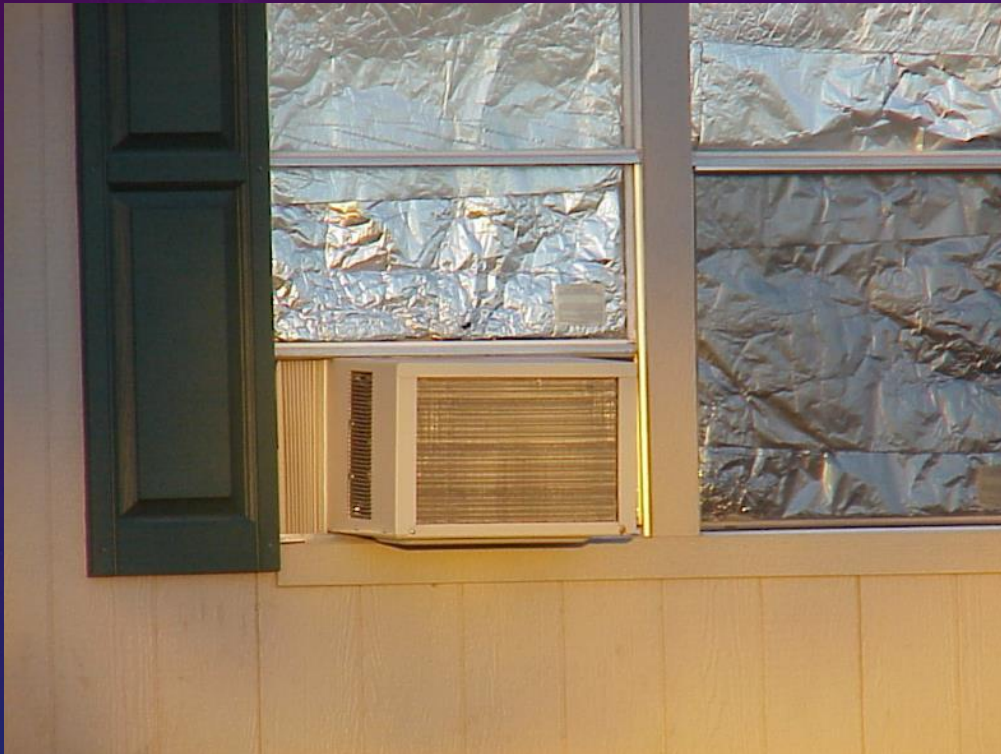
Window treatments
2 additional window a/c units

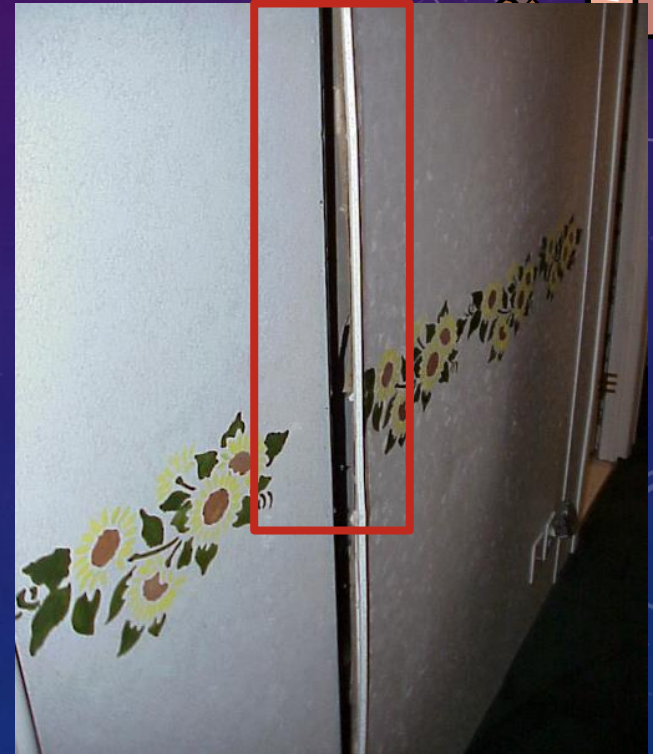
Wall panels buckling

- Building science problem solving
 - Testing (blower door, duct blaster, pressure mapping)
 - Observation
 - Documentation of operating conditions
- Findings: disconnected crossover duct
 - No cool air to one side of the house
 - Cool air spilling into crawl space
 - Super cooling surfaces – condensation, elevated RH, rust, rot, etc

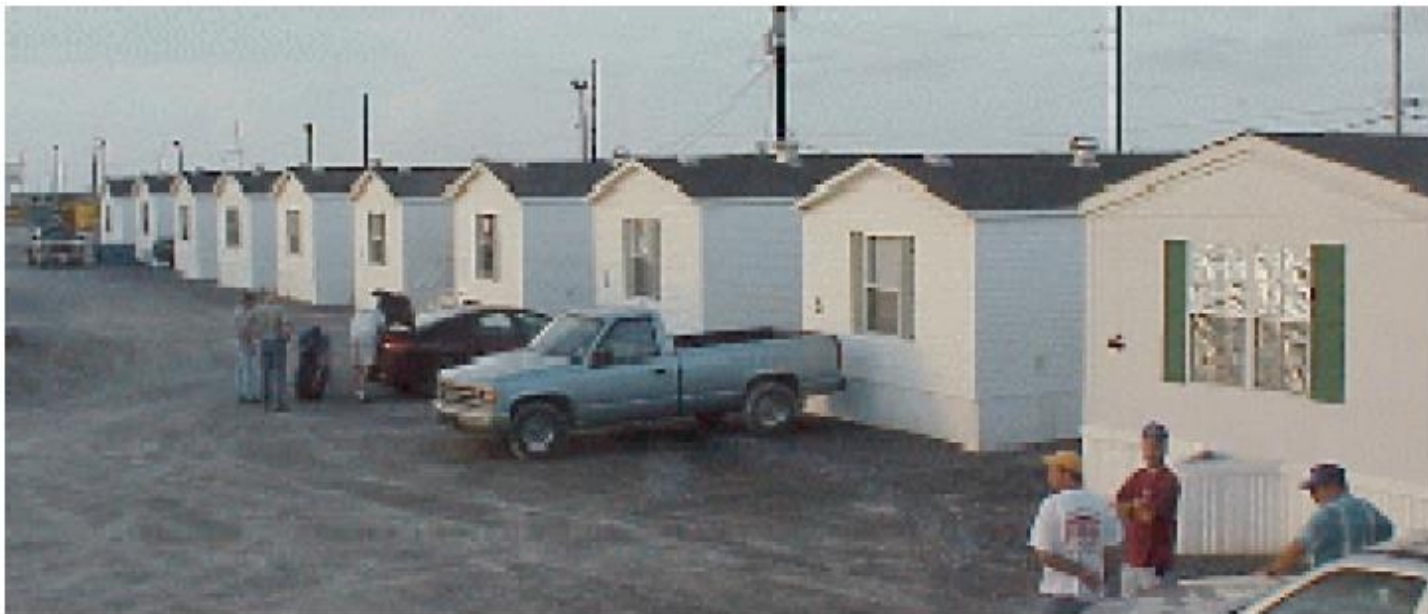
- 12 single wide homes "...moisture problems including high interior humidity, wall failures, and mold growth on floors and walls."
- 2 or 3 BR, 1008 ft², no ground cover
- Central split system HVAC
- Floor ducts, sheet metal trunk and risers

- Outside air 83 degrees 81% RH (dew point 76.6 degrees)
- Tstat set at 68 degrees – MOST SURFACES BELOW DEW POINT!
 - Soft interior wall panels
 - Exterior wallboard replaced
 - Material separation
 - Rust
 - Water in light fixtures

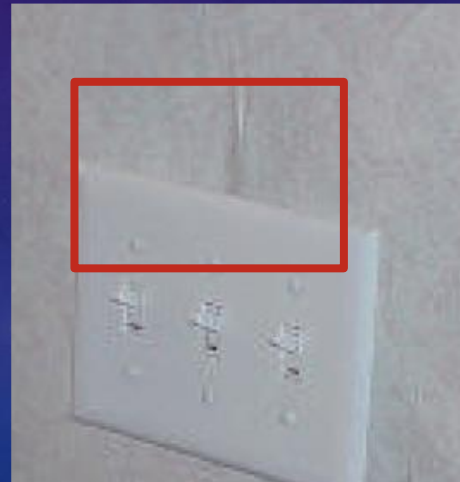
Moisture being pulled through wall cavity
Cool metal = condensation surface

- “The electrical panel box showed significant evidence of moisture; there was rust on many parts and a water stain was seen below the panel running to the floor.”

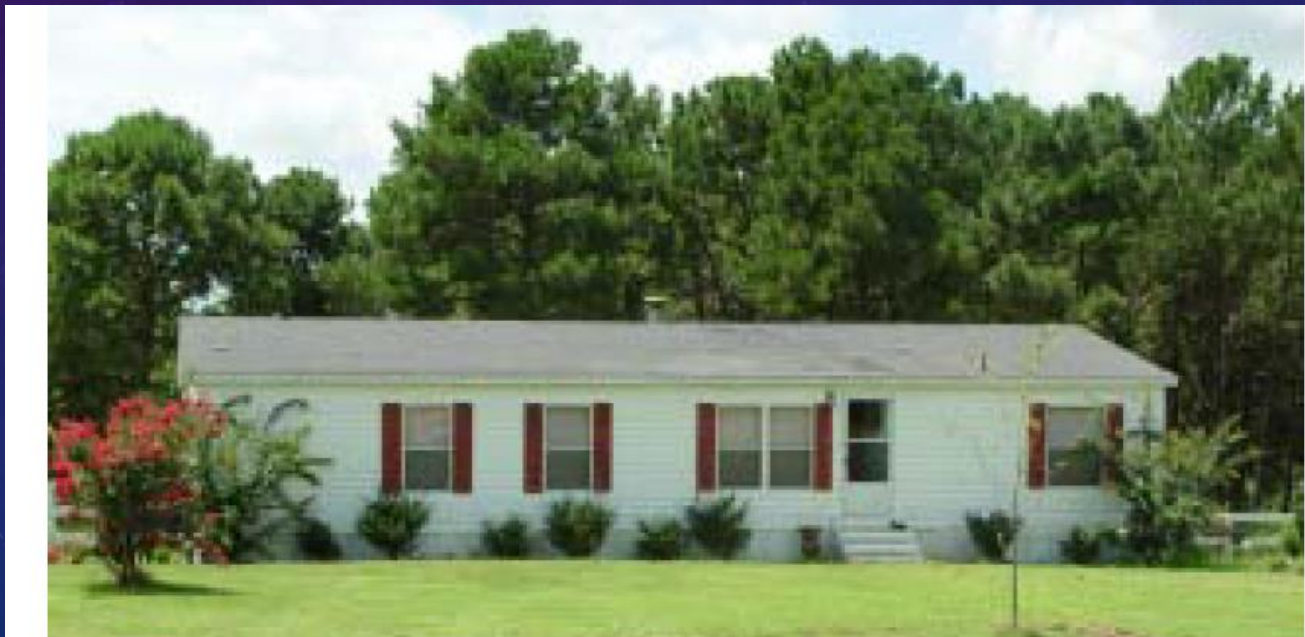
- 5 year old house, 3 bed, 2 bath
- 2 adults and one child
- Central heat, floor ductwork, down flow furnace

- Biological growth, staining problems, and condensation on interior surfaces

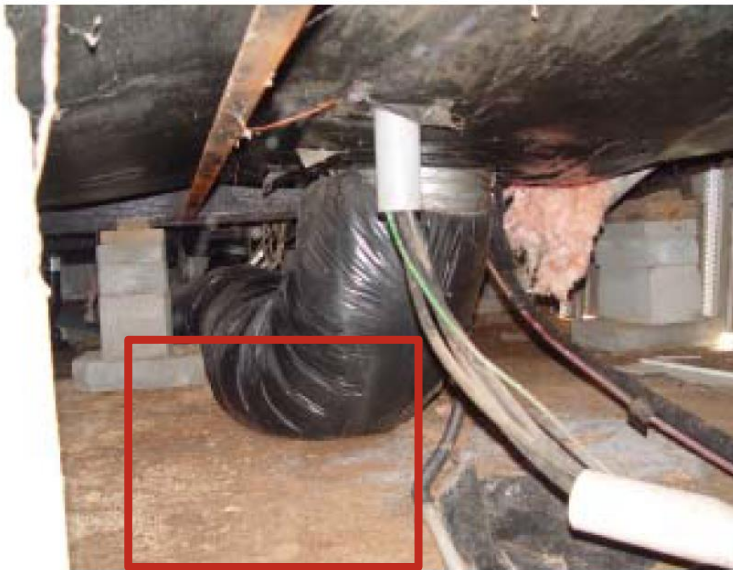
- No ground cover, duct in contact with ground
- Could be worse! No standing water, tide lines, or growth

Crossover duct at air handler unit

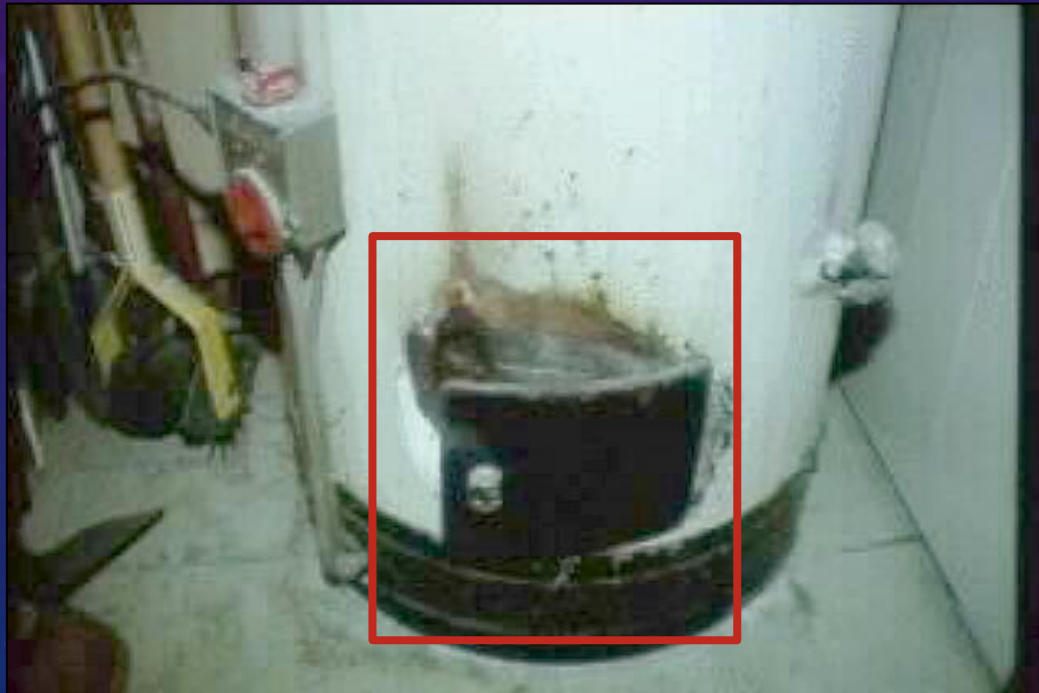
Lethal Failure: Depressurization is space with gas water heaters and furnaces

Flame Rollout and back drafting of exhaust fumes
